What Is Salt Killed Wood?

MISSISSIPPI STATE
UNIVERSITY
EXTENSION SERVICE

Publication 2662

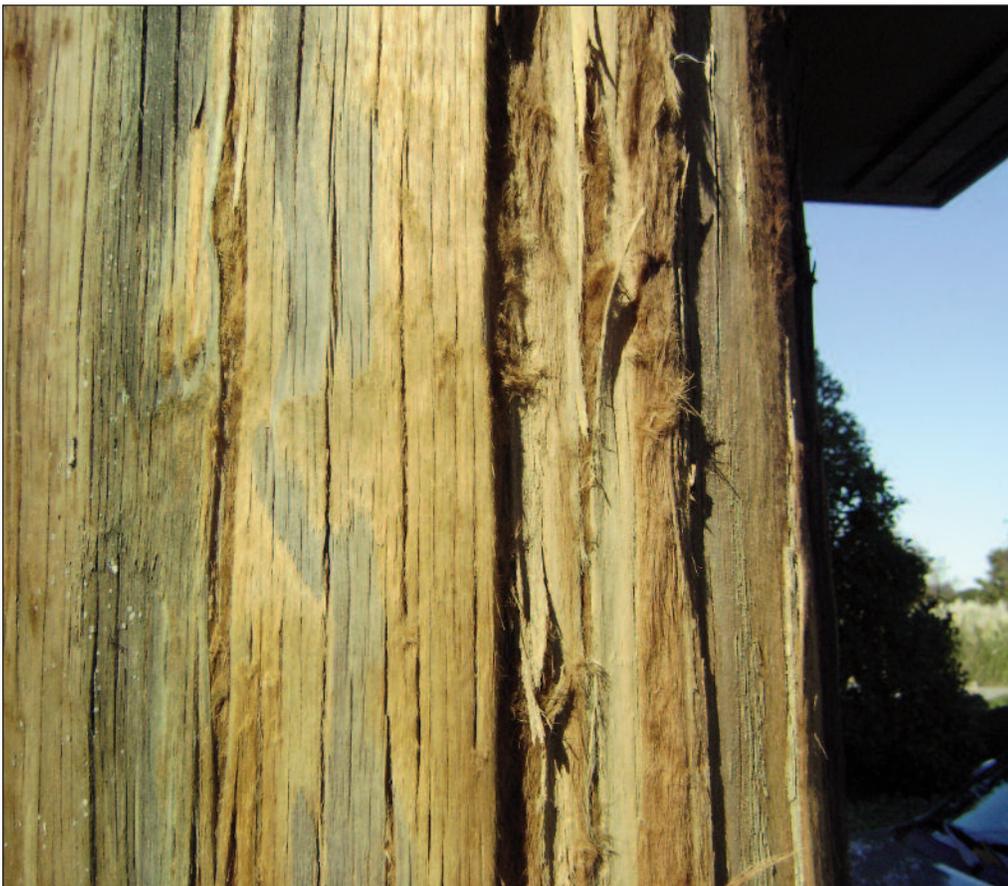
Figure 1. The chlorine in salt can, in certain circumstances, slowly degrade wood. High salt concentrations, high moisture levels, and warm temperatures can accelerate the process.

Under certain in-service conditions, salt can degrade wood. Table salt is a combination of chlorine (commonly used in bleach and in water treatment) and sodium. In certain circumstances, the chlorine in salt can slowly degrade wood. High salt concentrations, high moisture levels, and high temperatures can accelerate the process. Exposure to mechanical abrasion (foot traffic on decks), sunlight (south-facing structures), pressure washing, and wave action can accelerate deterioration.

Chlorine is a natural pulping agent of wood. As salt is deposited on or in wood, it often leaves a whitish, powdery residue on the surface. Under certain circumstances, the chlorine can be absorbed into the wood and soften the lignin. The result is a wood surface that looks fuzzy or stringy. This is because the individual cells that make up the wood retain their individual structure, but they are no longer stuck to each other. In addition to a fuzzy or stringy wood surface, a pile of wood dust, or pulp, may result.

Finally, salt-killed piers, pilings (Figure 1 and 2), seawalls (Figure 3), and other marine structures are common. This phenomenon occurs as intertidal salt from the water is deposited on the wood structures or wicks upward in the wood (similar to water wicking up a paper towel). In untreated wood or wood treated with water-borne preservatives, this chemical change is not uncommon, especially after many years of service.

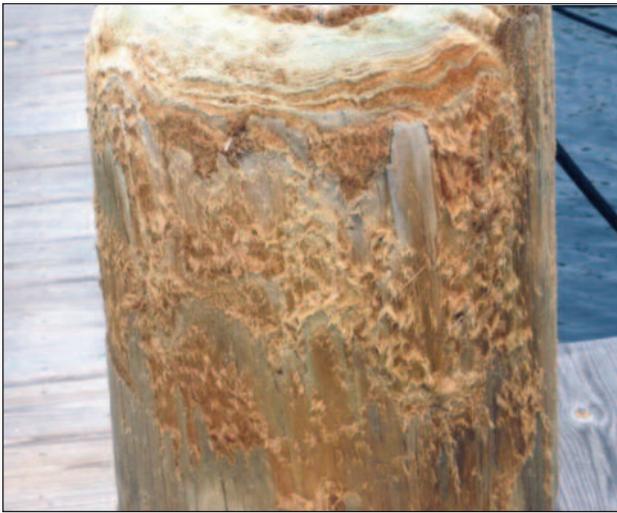
Figure 2. Salt killed piers, pilings, seawalls, and other marine structures are common.

Generally, only the outer shell of the wood is degraded, as this is the portion with the highest concentration of both salt and sunlight. A more permeable piece of wood will degrade faster than less a permeable piece of wood, even if both pieces are exposed to identical conditions.

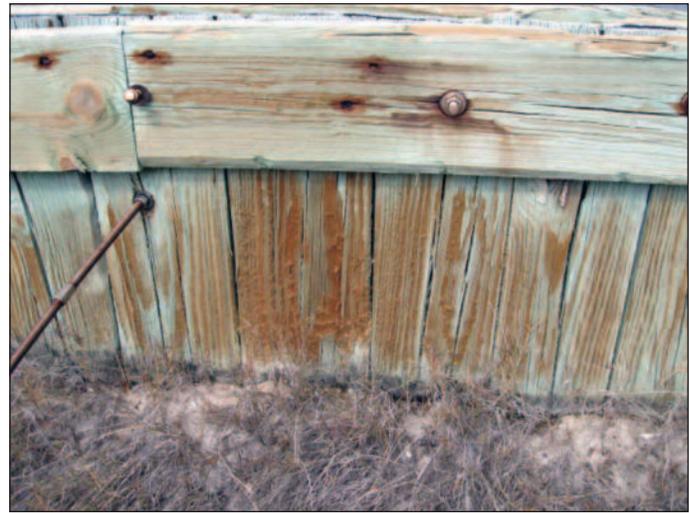
Figure 3. Salt kill occurs as intertidal salt from the water is deposited on the wood structures or wicks upward in the wood.
