Proper Earth Grounding in Mississippi Poultry Houses Can Prevent Lightning Damage

Publication 3321 (POD-06-23)

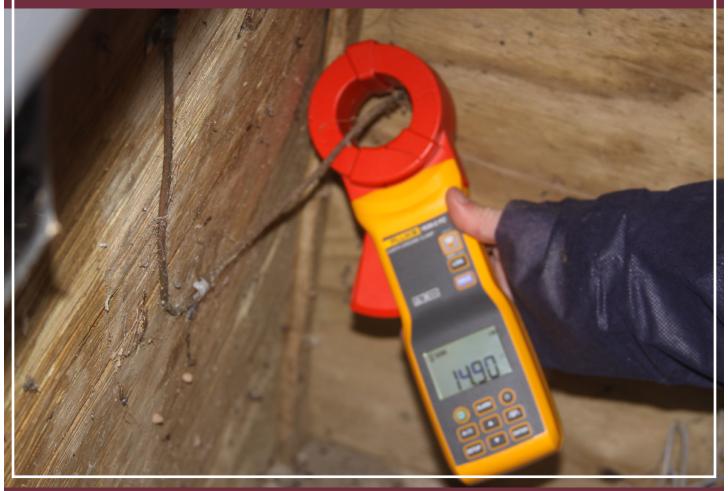
Figure 1. According to the National Electrical Code, a properly grounded system should have an earth ground resistance of 25 ohms (Ω) or less. This properly grounded control room breaker box is reading 14.90 Ω on the ground resistance meter.

reach earth ground. This pathway is important because. in electrical systems that are not grounded or improperly grounded, the electrical current from a lightning strike is forced through to generators, generator transfer switches, controllers, feed bin motors, etc., to find earth ground. Any equipment in an ungrounded or improperly grounded system that experiences excess current from a strike will be damaged and can catch fire. You can prevent equipment damage and fires by reducing the resistance in the path for lightning-induced current reaching to earth ground. Electrical resistance can be measured with a ground resistance meter like the one shown in Figure 1 and is reported in ohms (Ω). Prices for ground resistance meters vary from \$250 to \$2,000 and depend on the type and the manufacturer. According to the National Electrical Code (NEC), a properly grounded system should have an earth ground resistance of 25 Ω or less.

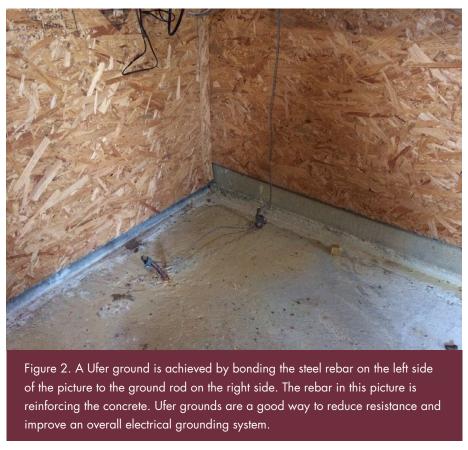
scenario, current dissipated from a lightning strike by the wall footer ground rod can travel through the soil, enter the adjacent rod and damage the controller. They should be bonded to a single ground rod as in Figure 2. It is also important that ground rods be driven into the ground to ensure good contact with the surrounding soil. Placing a ground rod in a hole that has been dug and then backfilling is not advised.

It is important to note that there should never be two independent ground rods close to each other. For example, there should not be a ground rod for the wall footer and a separate one for the control room breaker box. In this

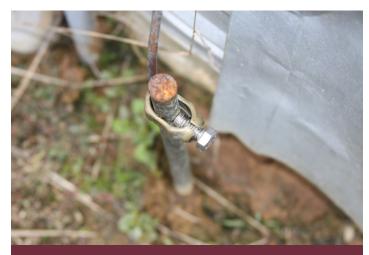
Figure 3. Broken clamps can increase resistance due to a poor connection. This problem should be corrected immediately. Inspecting ground wires, clamps, and rods yearly is a good idea.

Acorn-type solid ground clamps are most commonly used to connect ground wire to ground rods. The acornstyle clamps have proven effective and durable and are generally preferred over two-piece clamps. A solid connection must be made between the ground wire and ground rod to ensure the integrity of a grounding system. Be sure to check grounding connections every year because they can loosen over time and, as mentioned earlier, ground wires do occasionally get broken (Figure 3).

- Loose or broken ground wires and clamps were found during MSU's testing. It is a good idea to inspect all ground rods and clamps yearly.
- Acorn-type solid ground clamps are recommended over two-piece clamps.
