Proper Earth Grounding in Mississippi Poultry Houses Can Prevent Lightning Damage

Publication 3321 (POD-02-19)

By **John Linhoss**, PhD, Assistant Extension Professor, Agricultural and Biological Engineering; and **Jody Purswell**, PhD, USDA ARS Poultry Research Unit.

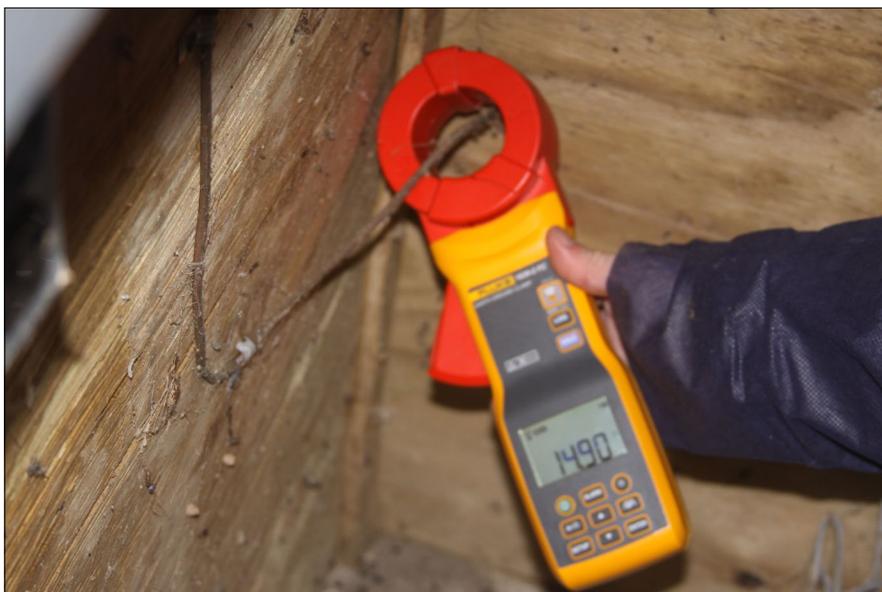
Figure 1. According to the National Electrical Code, a properly grounded system should have an earth ground resistance of 25 ohms (Ω) or less. This properly grounded control room breaker box is reading 14.90 Ω on the ground resistance meter.

for lightning-induced current reaching to earth ground. Electrical resistance can be measured with a ground resistance meter like the one shown in **Figure 1** and is reported in ohms (Ω). Prices for ground resistance meters vary from \$250 to \$2,000 and depend on the type and the manufacturer. According to the National Electrical Code (NEC), a properly grounded system should have an earth ground resistance of 25 Ω or less.

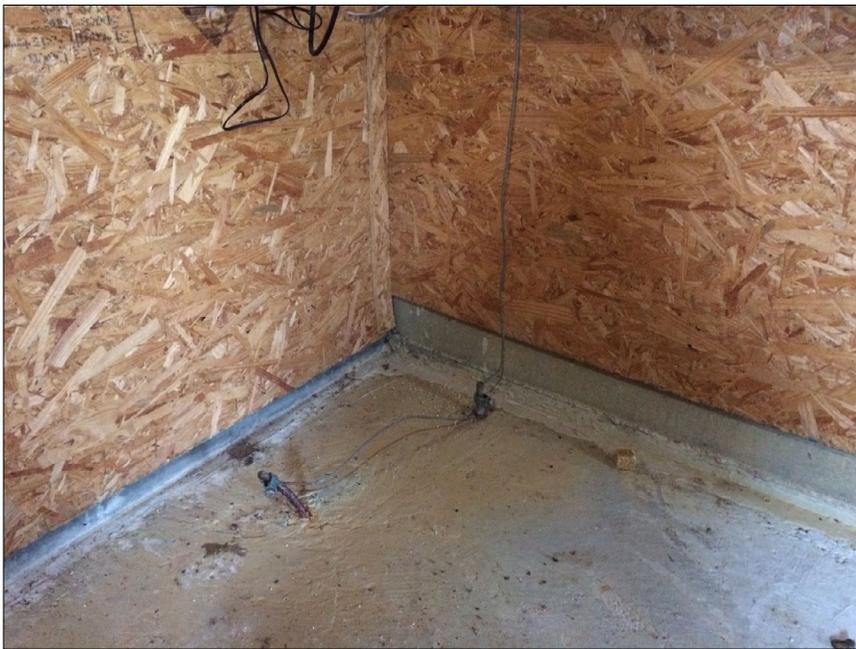
Figure 2. A Ufer ground is achieved by bonding the steel rebar on the left side of the picture to the ground rod on the right side. The rebar in this picture is reinforcing the concrete. Ufer grounds are a good way to reduce resistance and improve an overall electrical grounding system.

the wall footer ground rod can travel through the soil, enter the adjacent rod and damage the controller. They should be bonded to a single ground rod as in **Figure 2**. It is also important that ground rods be driven into the ground to ensure good contact with the surrounding soil. Placing a ground rod in a hole that has been dug and then backfilling is not advised.

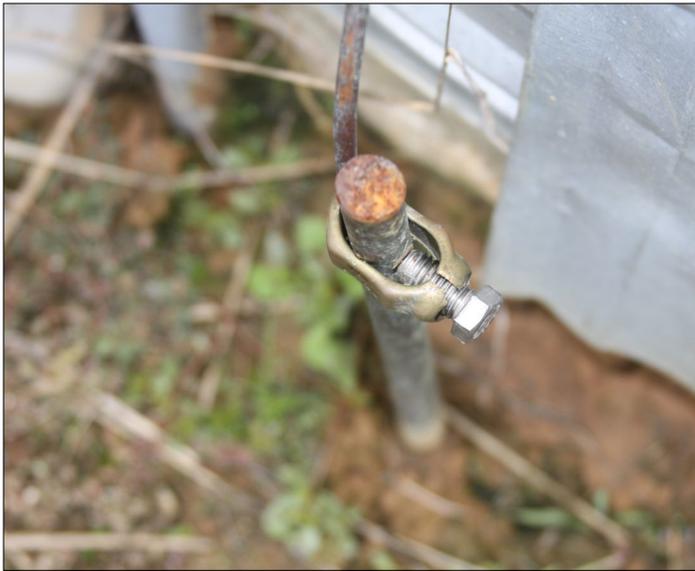
Figure 3. Broken clamps can increase resistance due to a poor connection. This problem should be corrected immediately. Inspecting ground wires, clamps, and rods yearly is a good idea.

check grounding connections every year because they can loosen over time and, as mentioned earlier, ground wires do occasionally get broken (**Figure 3**).
